# PUBLIC ROADS

A JOURNAL OF HIGHWAY RESEARCH

VOL. 5, NO. 2

APRIL, 1924

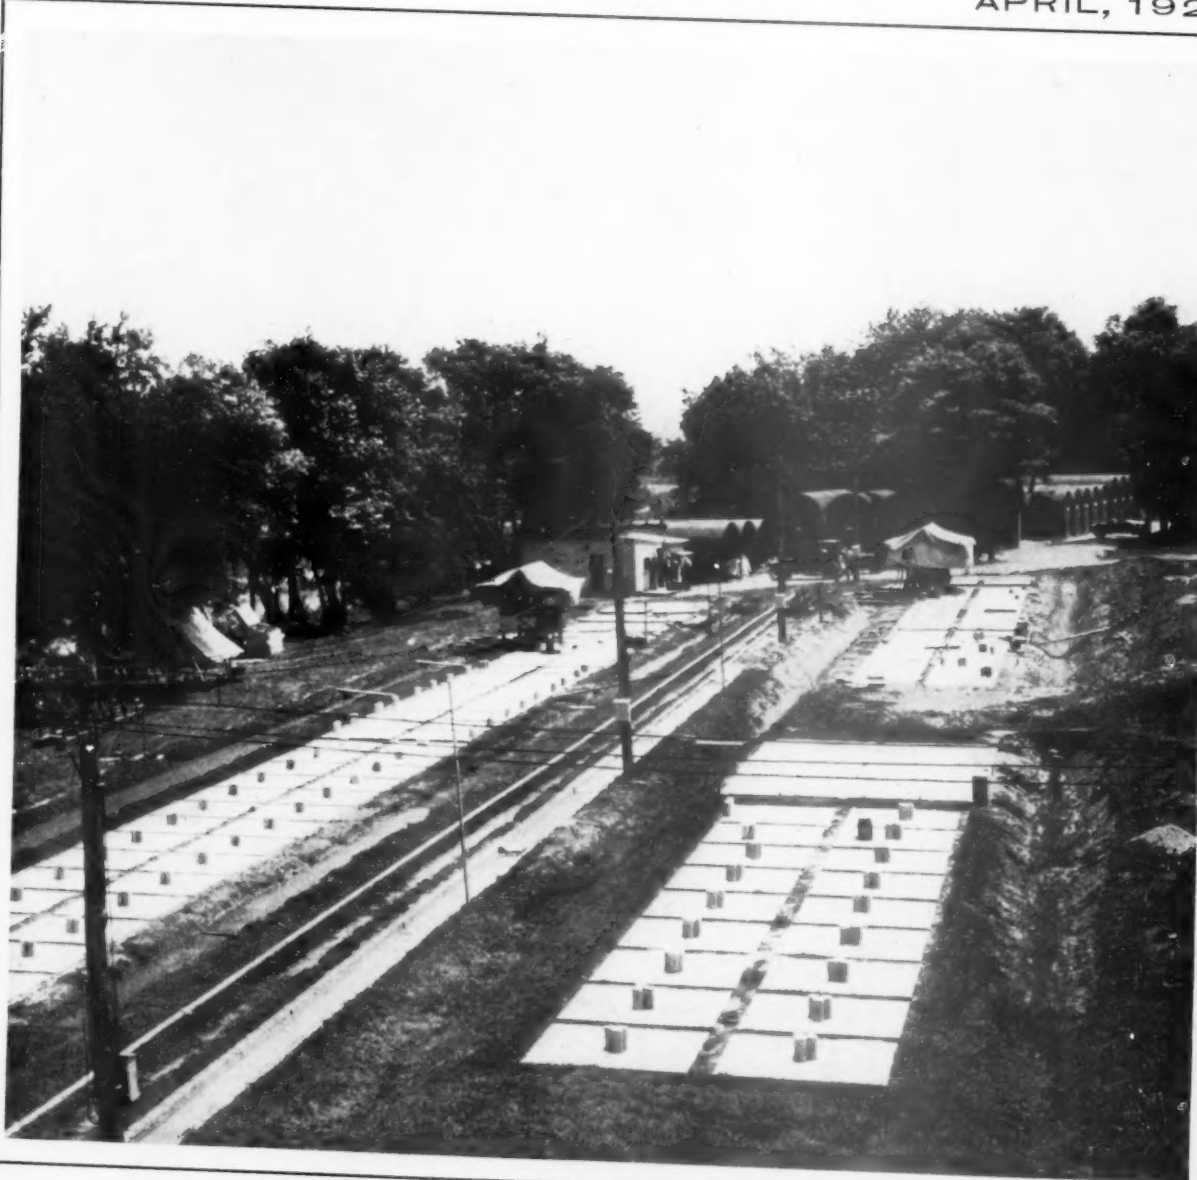
GENERAL VIEW OF SLABS FOR IMPACT TEST, ARLINGTON, VA.

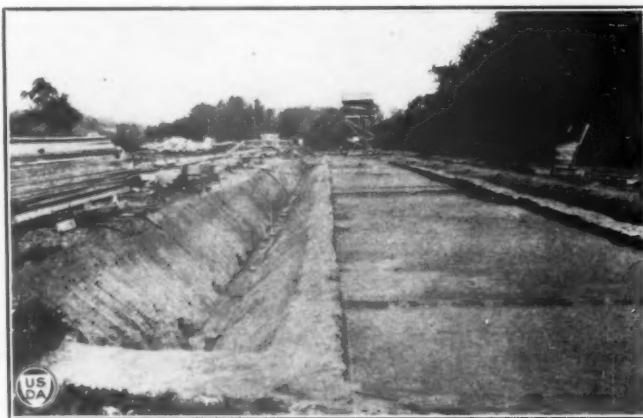
Construction view—wet subgrade section showing tile cross drains and subgrade cut for slabs of various thickness.

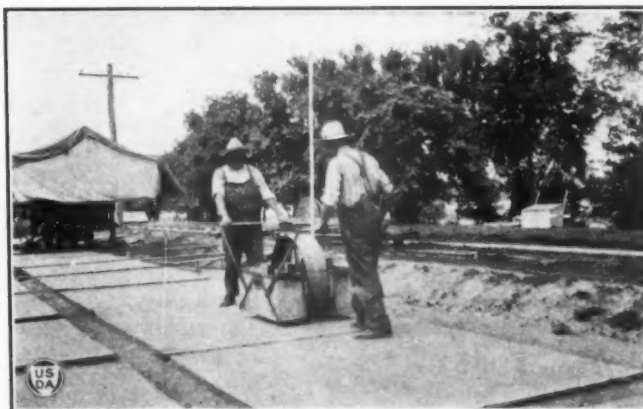
Rolling asphalt tops. Roller weight, 250 pounds per inch of width.

Four and six inch concrete bases on the wet-subgrade sections were cracked in rolling the bituminous tops, the lean mixes being badly broken up. This unfortunate occurrence eliminated several very interesting sections from the tests, but it is worth noting that 6-inch 1: 1½: 3 concrete bases were cracked in construction where a fairly bad subgrade condition obtained, while 4 inch bases of the same mix withstood the same roller loads undamaged on a good subgrade. While the ditches surrounding the wet-subgrade sections had not been filled with water up to the time the rolling took place, the position of these sections at the foot of the hill and the presence of capillary water created a naturally poorer subgrade condition than that which existed in the dry-subgrade sections.

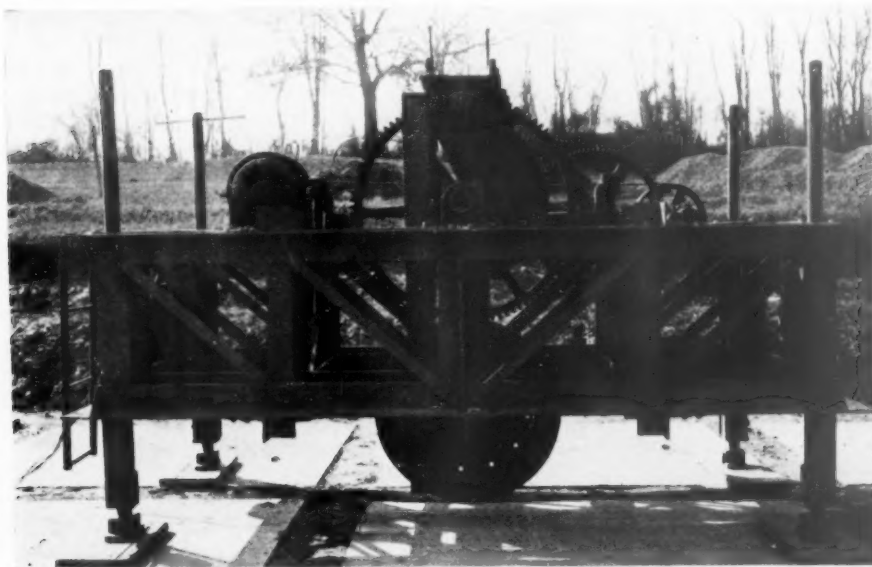
TOP.—THE IMPACT MACHINE.

BOTTOM.—CLOSE-UP OF IMPACT MACHINE AND SET-UP OF APPARATUS FOR THE EDGE TEST, SHOWING GRAPHIC STRAIN GAUGES IN TOP AND BOTTOM OF THE CONCRETE BASE, DEFLECTION DIAL, THERMOMETER IN BITUMINOUS MATERIAL, AND ACCELEROMETER MOUNTED ON SHELF BELOW AXLE.

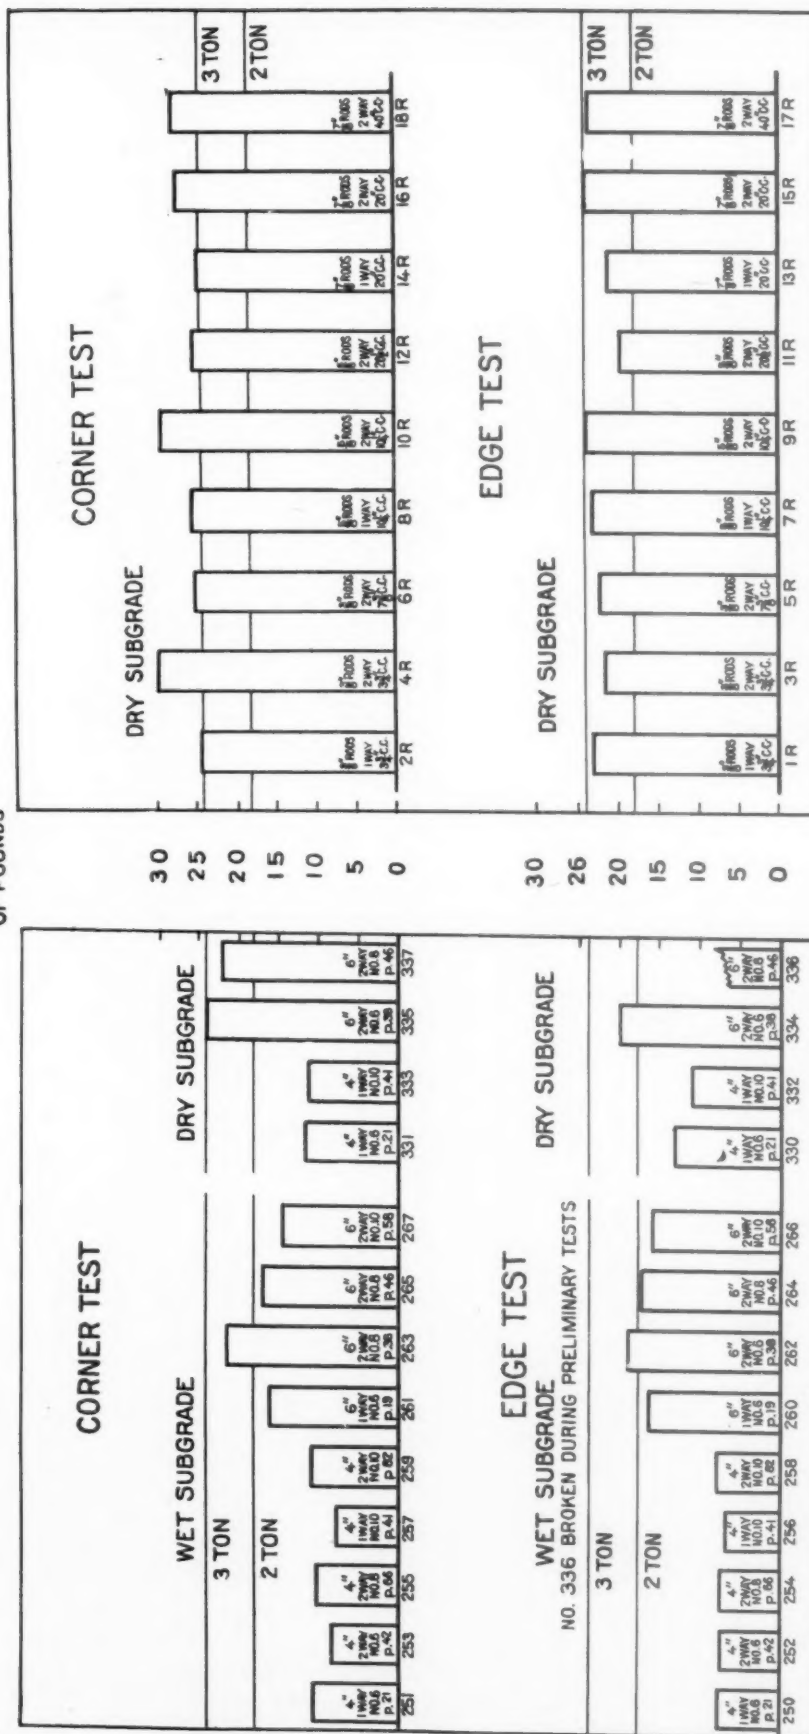
## ROD-REINFORCED CONCRETE SLABS

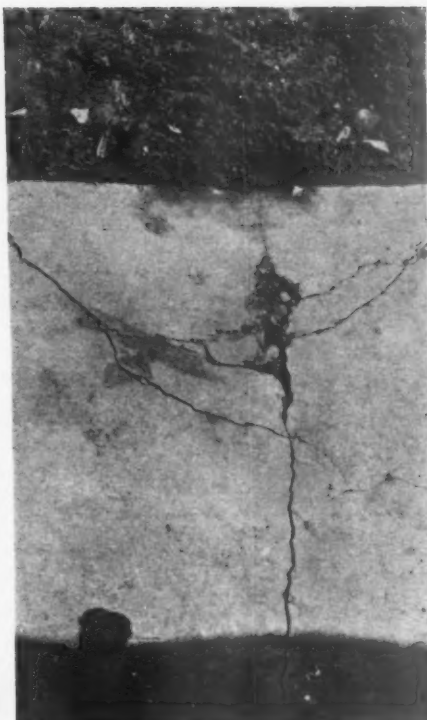
Transverse crack with corners broken off in a 4-inch, mesh-reinforced concrete slab.

Typical failures in edge tests of concrete slabs laid on wet subgrade.

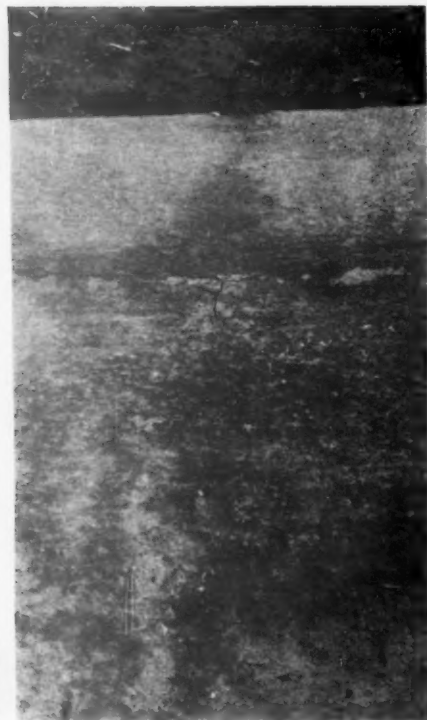
Transverse and longitudinal crack resulting from impact on an 8-inch, 1:3:6 plain concrete slab.

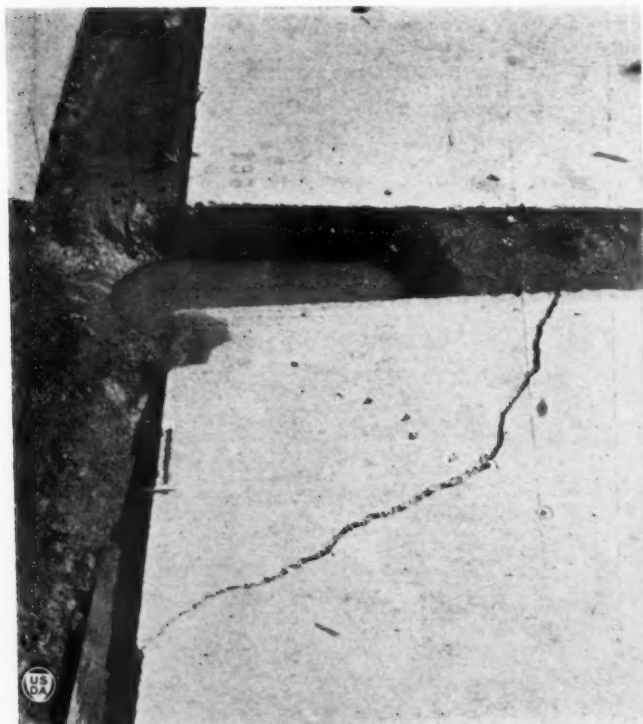
6-inch mesh-reinforced concrete slab.

Typical failures in corner tests of concrete slabs laid on wet subgrade.

The corner test caused a curved crack across the corner due to tension in the top fibers of the slab. The unit fiber deformation at failure was the same

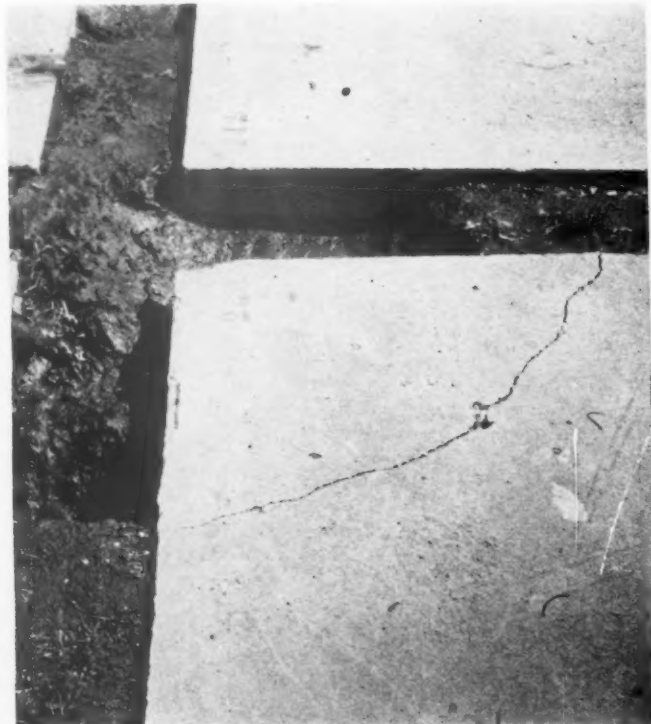
6-inch plain concrete slab.

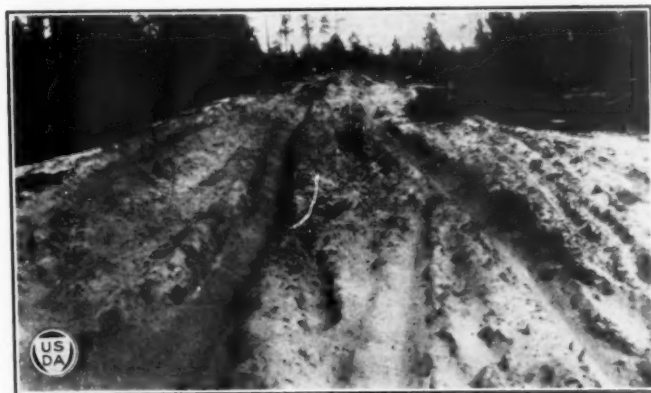
Fig. 1.—Graded natural Florida soil road. State Route No. 2, south of Crescent City.

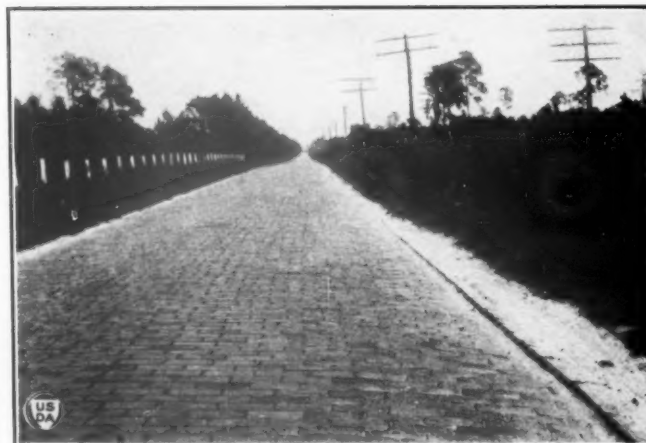
Fig. 2.—State Route No. 1 between Jacksonville and Lake City, showing lack of "beam strength."

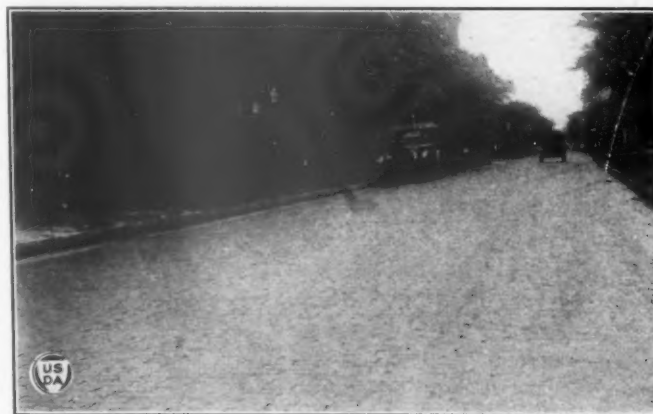
Fig. 3.—Park Avenue, Sanford—A sand-filled pavement in the first stage of deterioration, still giving excellent traffic service.

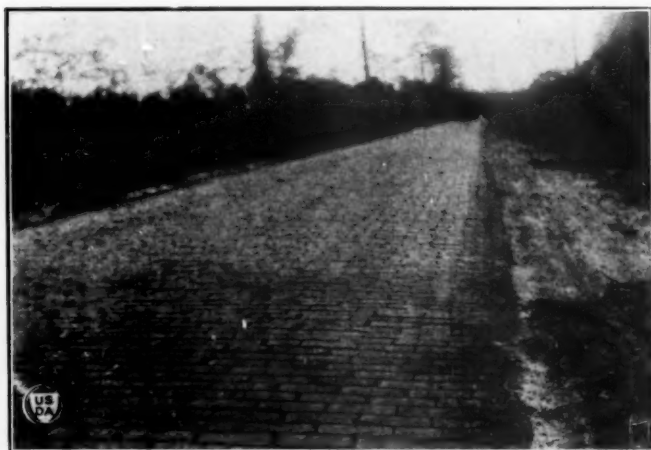
FIG. 4.—Bituminous-filled relaid brick surface between Jacksonville and Atlantic Beach, giving good service though in the first stage of deterioration.

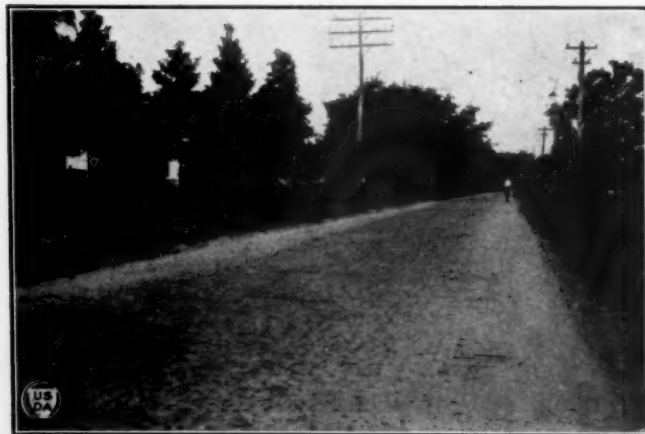
FIG. 5.—Cement-grout-filled brick surface, State Route No. 1, near Jacksonville, giving excellent service after four years, though in the first stage of deterioration.

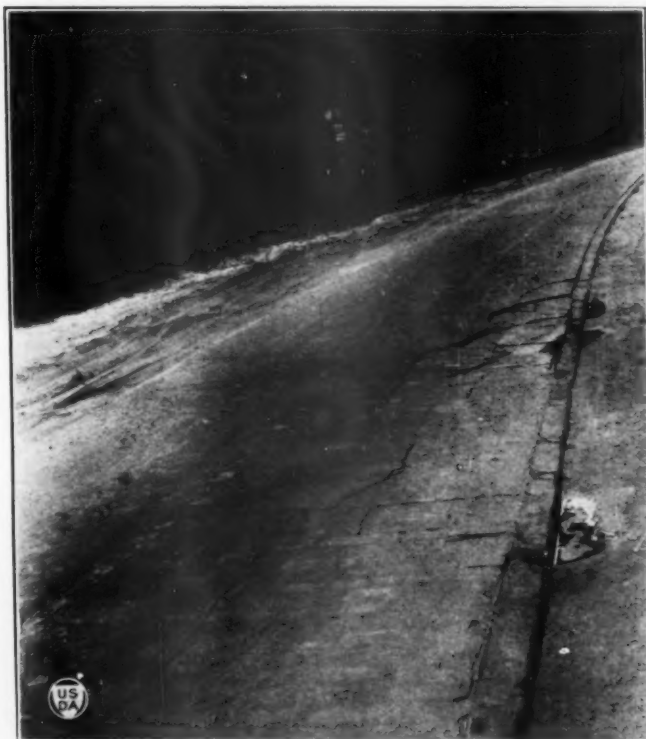
FIG. 6.—Break on curve of cement-grout-filled surface—State Route No. 2, between Orlando and Sanford.

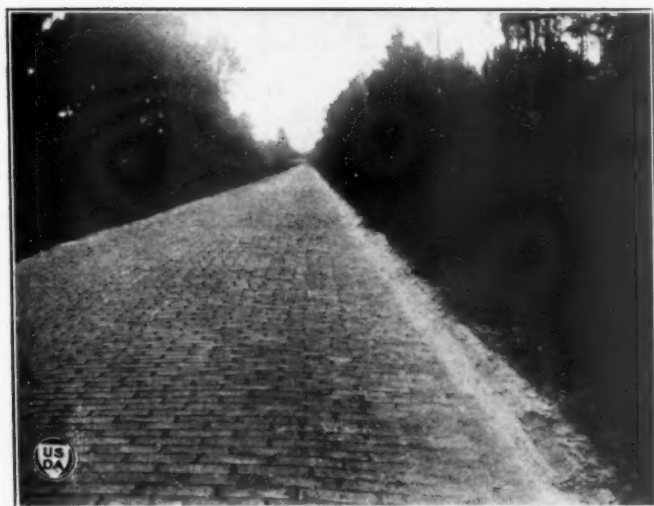
FIG. 7.—Sand-filled brick surface, north of Jacksonville. In the second stage of deterioration but still giving good service.

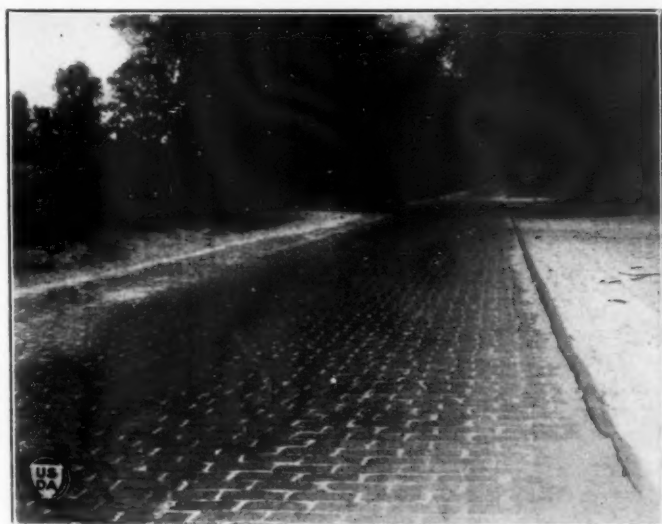
FIG. 8.—Section of sand-filled brick pavement with depressed center—State Route No. 4—north of Jacksonville. Although water has flowed down the middle of this road for 14 years it still presents a good riding surface.

Two sections of the above road each one-half mile in length were constructed with depressed centers, as shown in Figure 8. More or less uniform depression of brick along the edges was noted, as well as a slight depression several feet from the left-hand edge. The curbs were pushed out of line, but the sand filler seemed to be intact. These depressed-center sections were constructed in 1909, after serious washing of the shoulder of the previous pavement. Although water had been flowing down the middle of the road for something like 14 years, these sections presented very good riding surfaces. They also eliminated the trouble found on the majority of Florida roads—that of water standing in depressions along the curb.

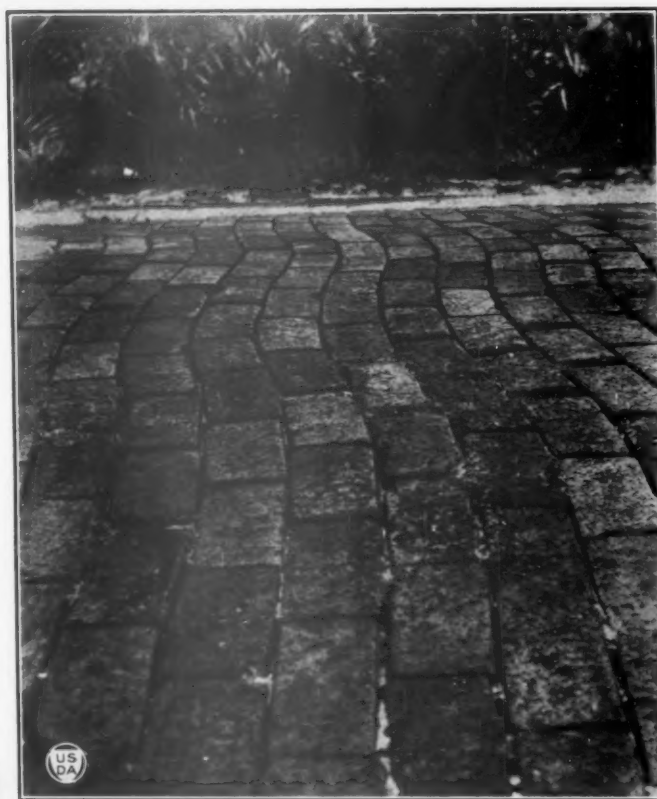
FIG. 9.—Section of sand-filled surface between Jacksonville and Atlantic Beach, showing movement of brick and loss of filler.

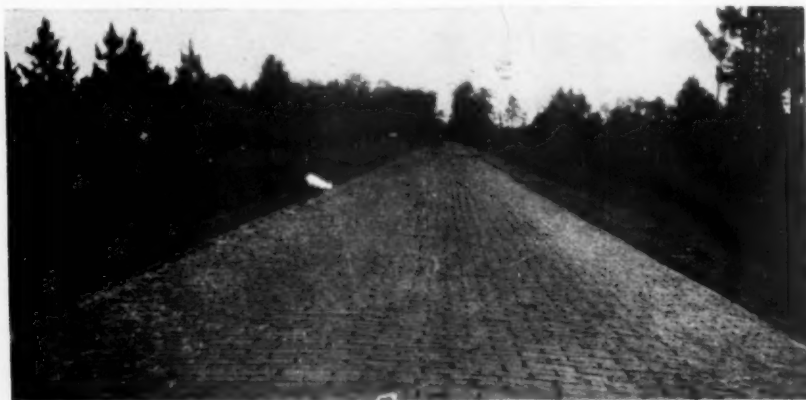
Fig. 10.—(UPPER) SAND-FILLED SURFACE ON STATE ROUTE NO. 4, JACKSONVILLE TO ST. AUGUSTINE, SHOWING DEPRESSION OF THE EDGES OF THE PAVEMENT. (LOWER) ANOTHER VIEW OF THE SAME ROAD SHOWING MARKED UNEVENNESS.

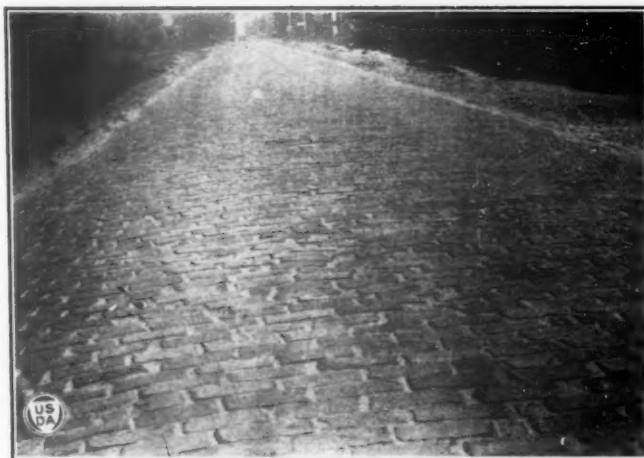
FIG. 12.—Sand-filled brick surface with wood curbs, between Orlando and Sanford. This surface is in the third stage of deterioration. Note the settlement and separation of the brick.

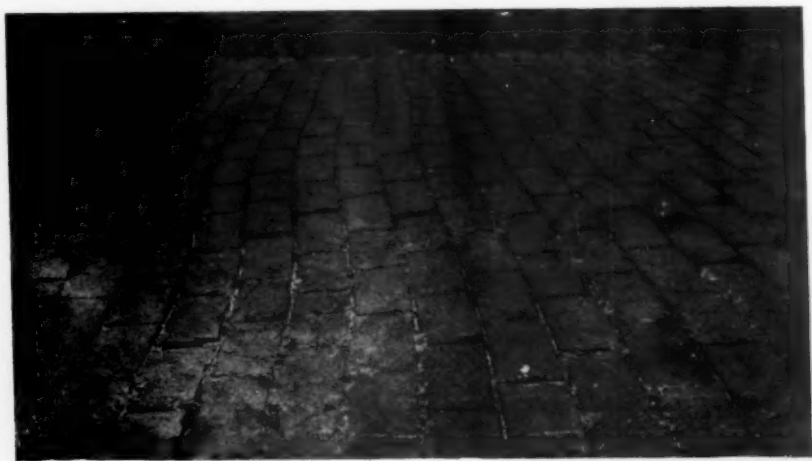
FIG. 13.—(UPPER) LONGITUDINAL MOVEMENT OF BRICK IN THE ORANGE PARK ROAD. NOTE GRASS GROWING IN THE SAND FILLER. (LOWER) TRANSVERSE SEPARATION OF BRICK PERMITTED BY SPREADING OF CURBS.

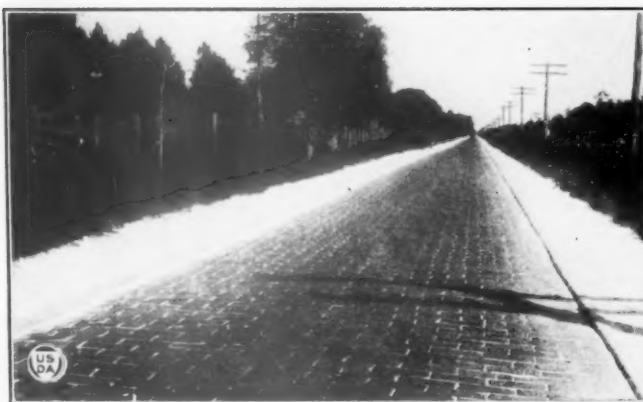
FIG. 15.—Showing settlement in a narrow, sand-filled surface laid on a shell base. This is a section of the Jacksonville-St. Augustine road.

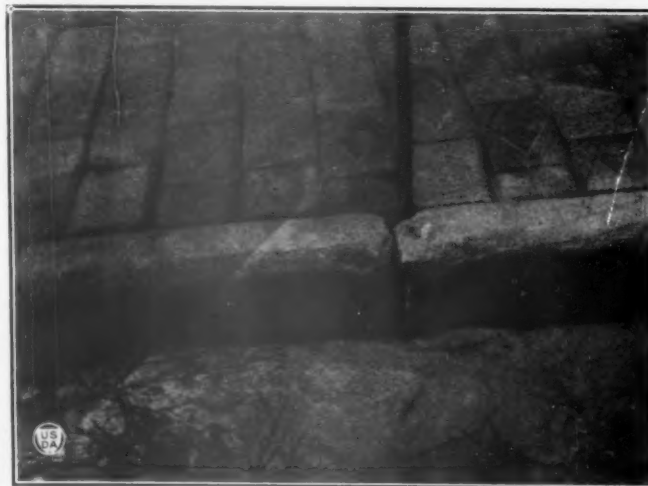
FIG. 16.—View showing absence of shoulder and wide, open curb joint on the Tildenville road.

Figure 16, a view of the Tildenville Road, relaid April, 1923, shows the absence of shoulders and a space one-half inch wide between sections of relaid

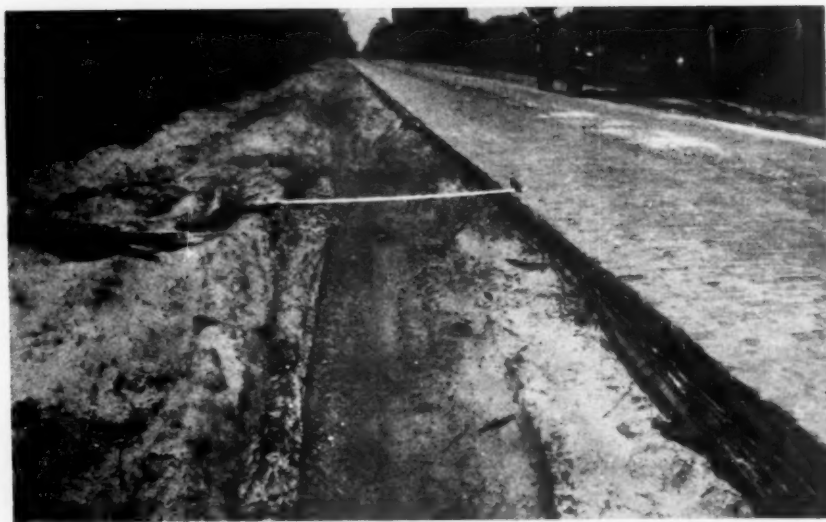
FIG. 17 (LEFT).—SHOWING GOOD CONDITION OF CEMENT-GROUT-FILLED SURFACE NOTWITHSTANDING THE LOSS OF THE SHOULDERS AND WOODEN CURBS.

FIG. 18 (RIGHT).—SHOWING HOW EDGES FAILED WHERE WATER STOOD NEAR THE ROAD SURFACE AND SHOULDERS WERE WASHED AWAY.

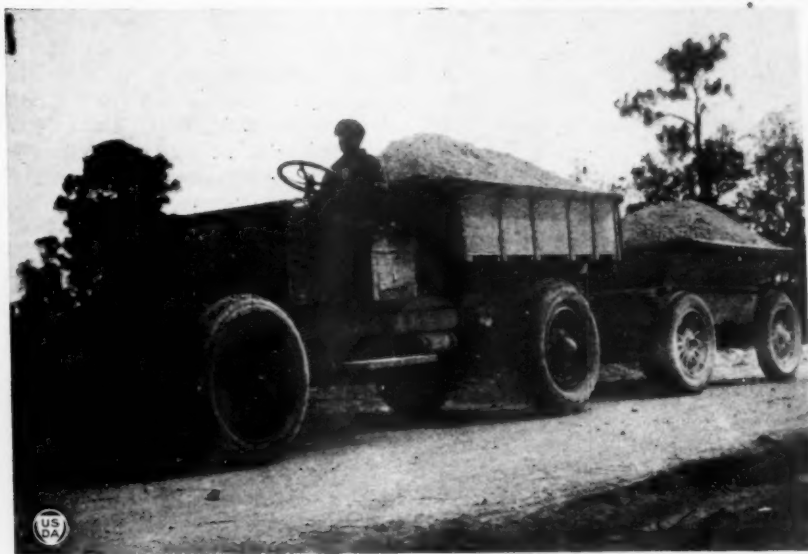
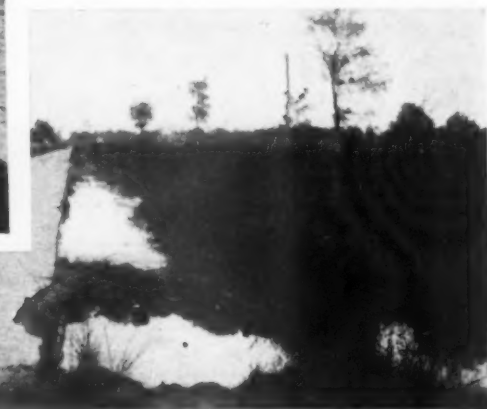
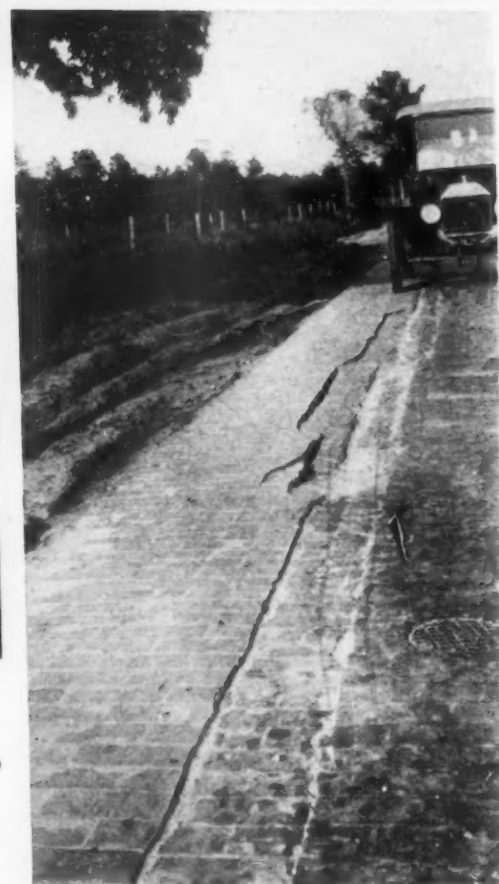
FIG. 19 (RIGHT).—THIS BREAK COULD NOT HAVE OCCURRED HAD NOT THE SAND SUBGRADE BEEN DISPLACED.

FIG. 20 (ABOVE).—THE KIND OF TRAFFIC WHICH CAUSED THE DAMAGE.

VIEWS ILLUSTRATING THE DETERIORATION OF THE CEMENT-GROUT-FILLED ORLANDO-BITHLO ROAD AND THE CHARACTER OF THE TRAFFIC WHICH PROBABLY WAS RESPONSIBLE FOR THE DAMAGE.

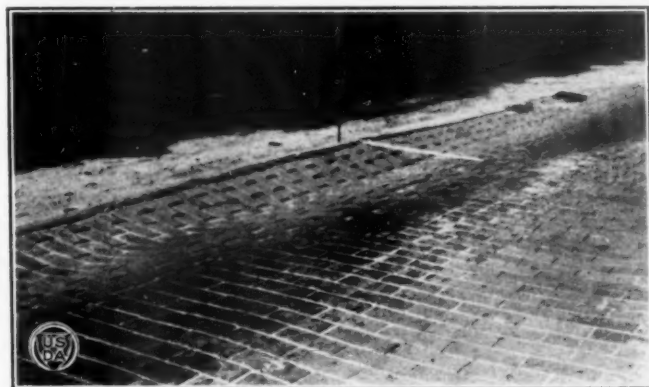
FIG. 21.—Depression in Orlando-Winter Garden road, probably caused by displacement of the sand subgrade, due to vertical movement of the curb.

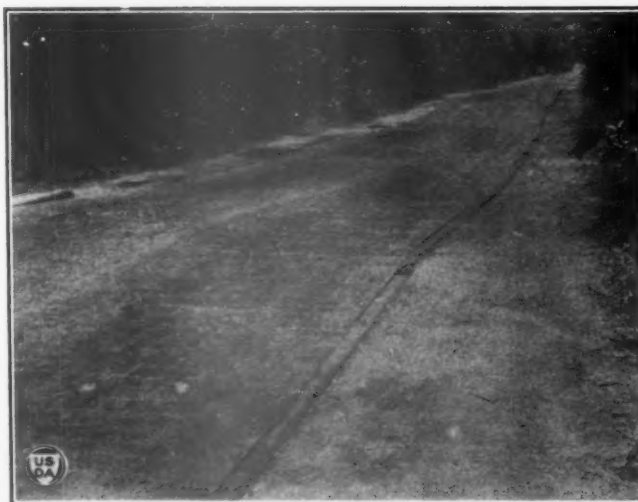
FIG. 23.—Section of a cement-grout-filled surface laid through a swamp section south of Kissimmee which has conformed to changes in the sand subgrade without becoming rough.

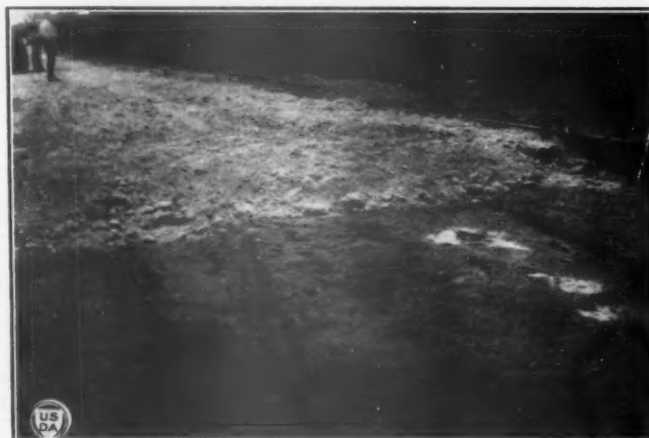
FIG. 24.—Limerock base before rolling.

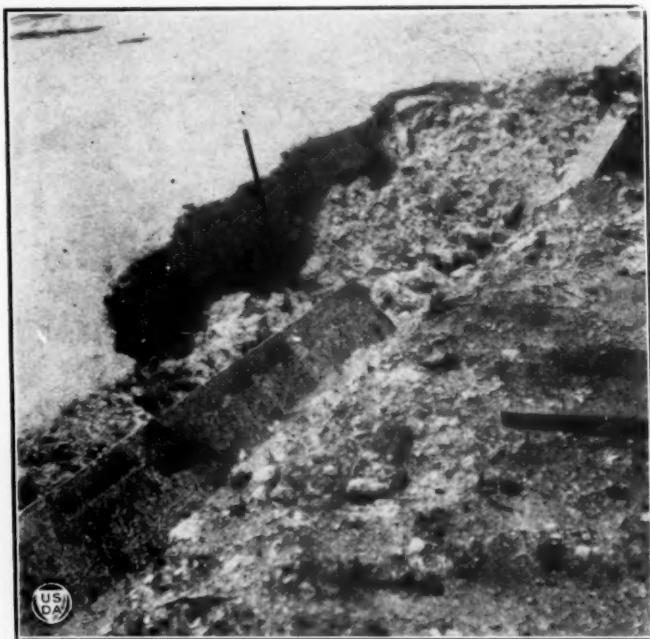
FIG. 25.—Failure of limerock base due to washout of sand subgrade. Note the smooth surface obtained by rolling.

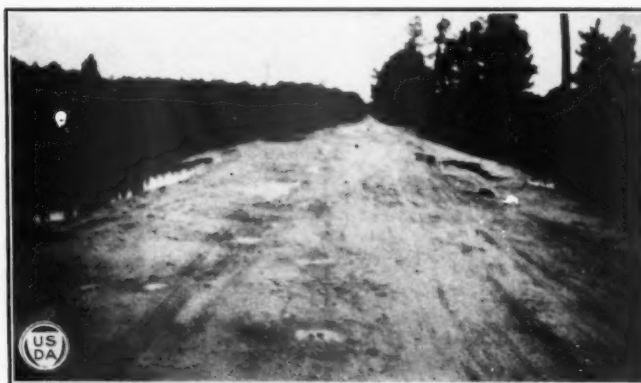
FIG. 26.—Limerock road compacted by traffic. Laid in 1914.

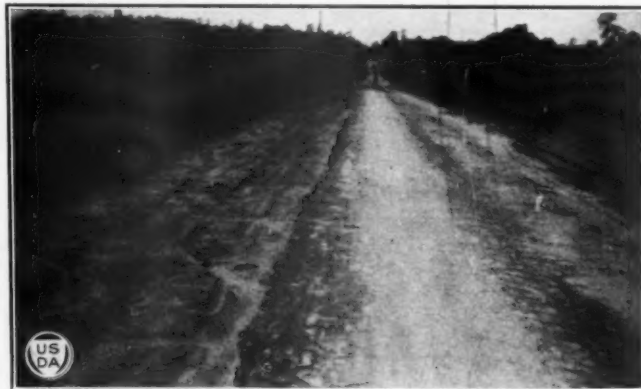
FIG. 27.—Limerock road compacted by road roller. Built in 1913 and carefully maintained, it is now a very satisfactory, hard, and compact road.
